Emergency Roadside Technician Dies When Struck by a Single-Unit Truck on an Interstate Shoulder

Incident Number: 05KY001

Kentucky Fatality Assessment and Control Evaluation (FACE) Program
Incident Number: 05KY001
Release Date: August 3, 2007
**Subject: Emergency Roadside Technician Dies When Struck by
a Single-Unit Truck on an Interstate Shoulder**

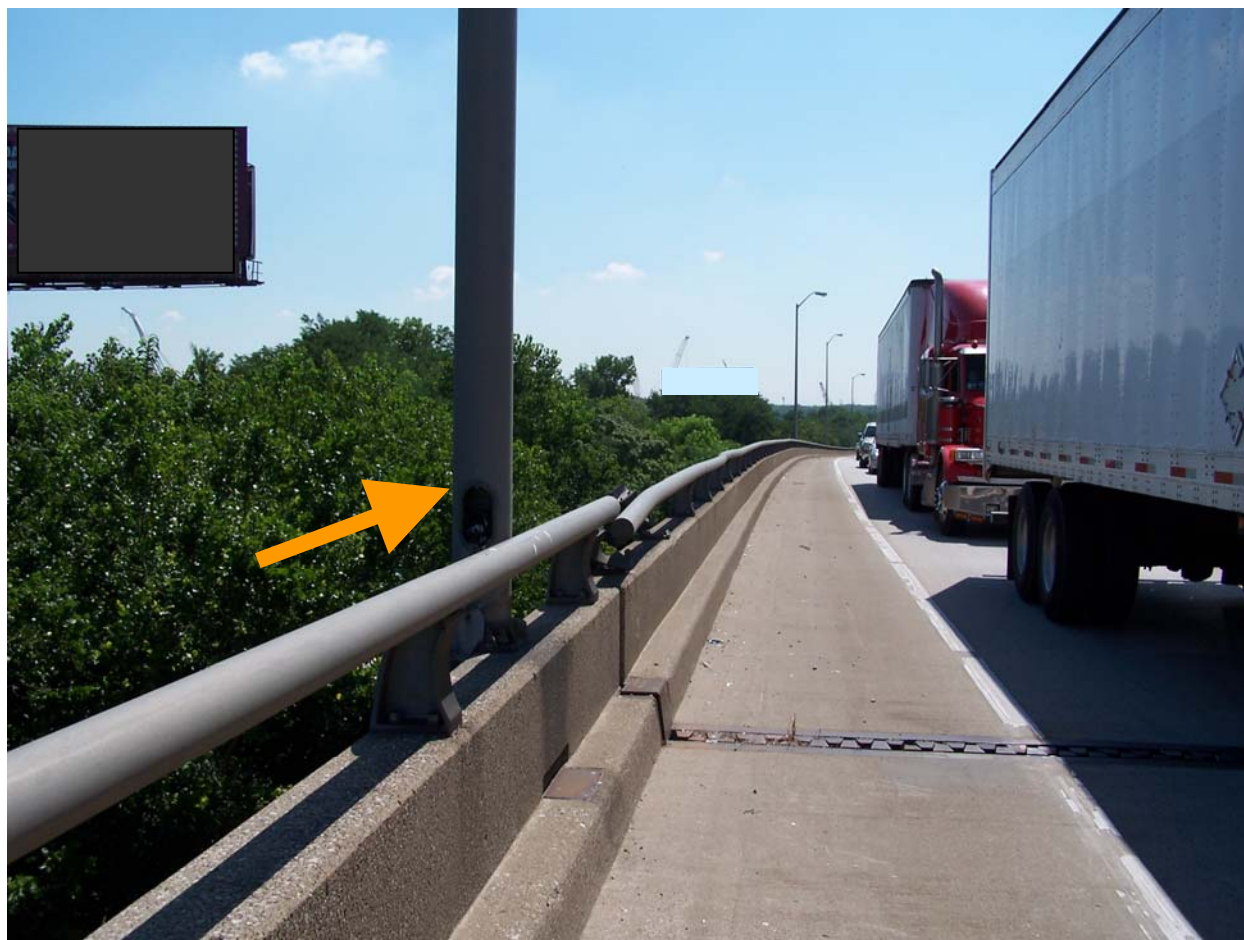
Location on bridge where responder attempted to avoid semi.
